FEASIBILITY STUDY

# CRISFIELD DOWNTOWN

SAGE POLICY GROUP

JANUARY 2020

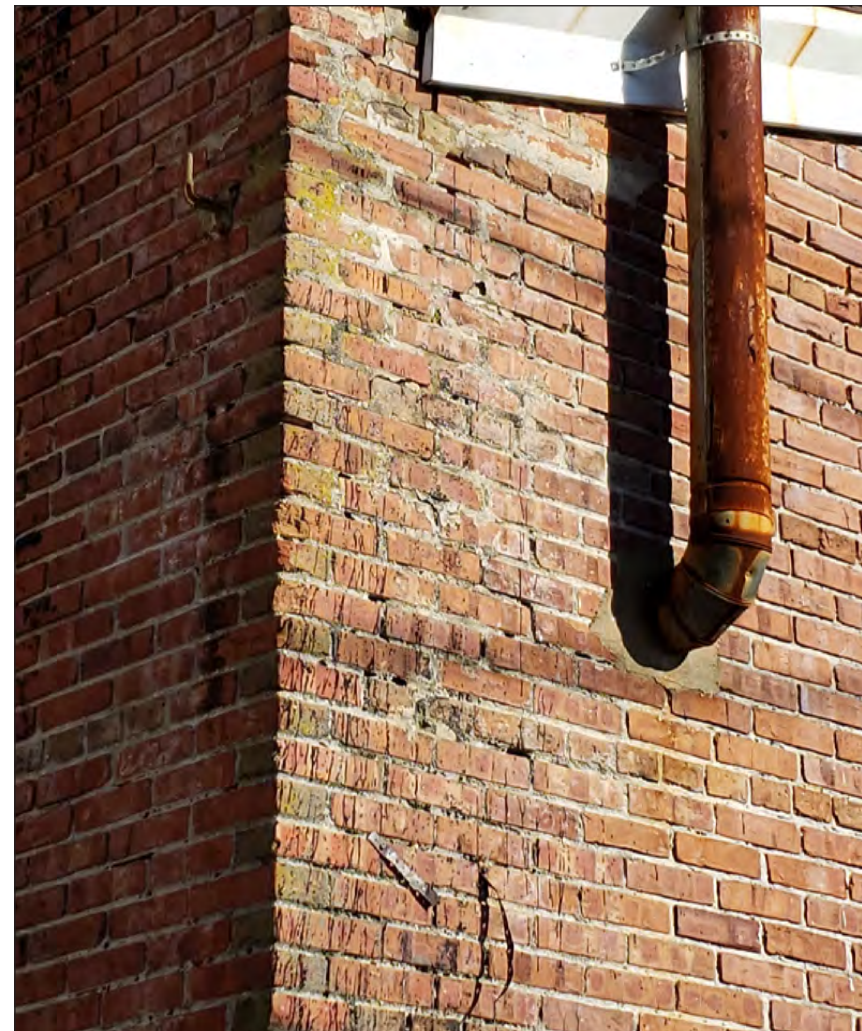
- Presence of efflorescence and cracked masonry was observed at the southwest corner of the building

BRICK CONDITION

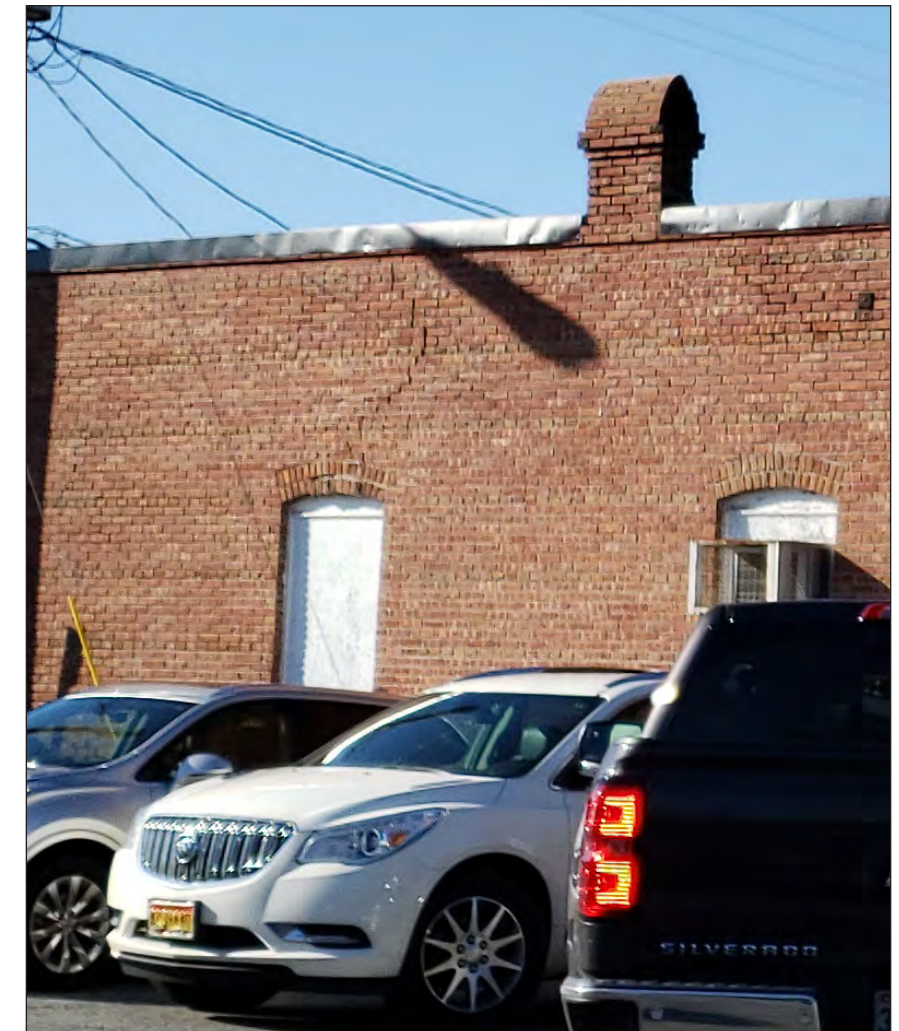
- Cracked masonry was observed on the east façade.

BRICK CONDITION

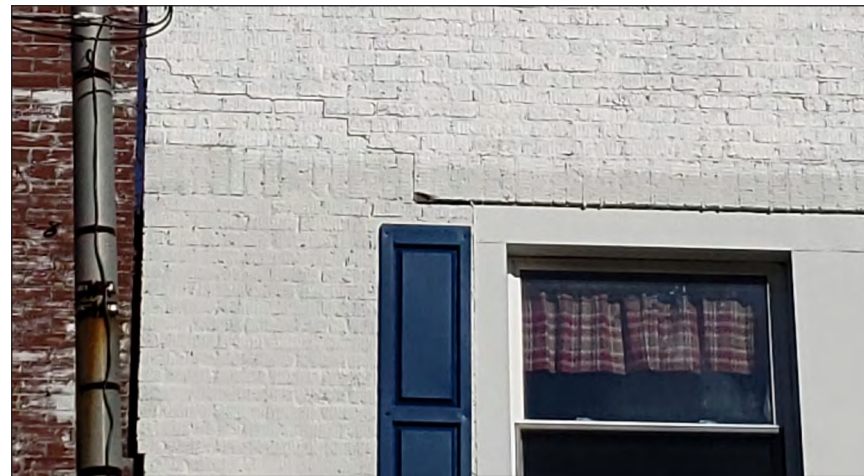
- Lintel corrosion and masonry racking
- Cracking of masonry at the upper parapet/roof line

TYPICAL CONDITIONS AT LINTELS

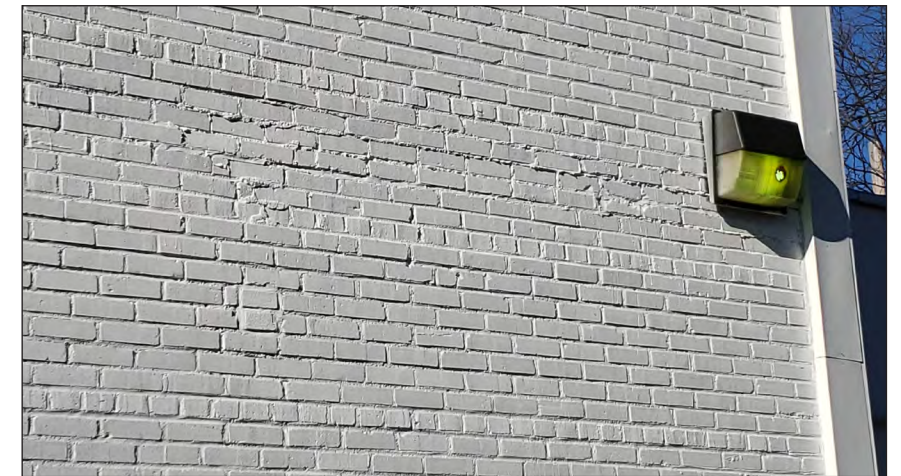
- Appearance of masonry displacement/cracking

EAST FAÇADE

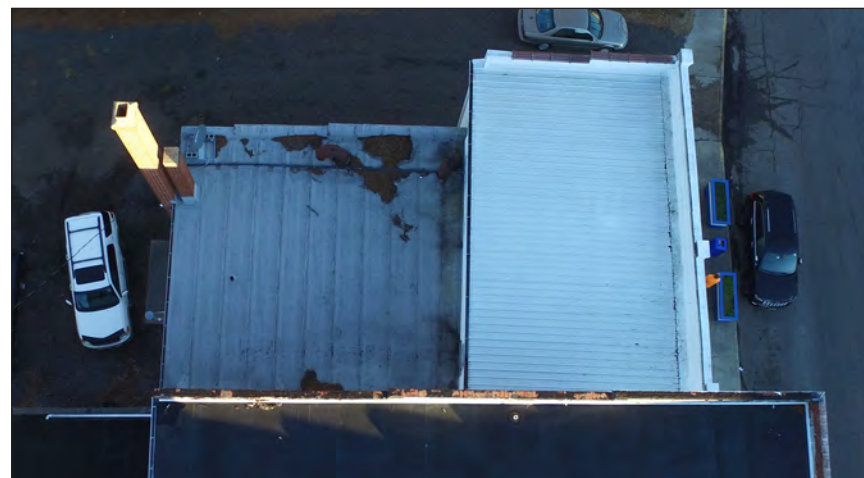
- Various areas indicate potential water infiltration on the roof of building 322
- Deterioration of the adjoining masonry wall at the roof level between 322 & 324 causing debris.

ROOF CONDITION

- The roof should be inspected by a roofing manufacturer or installer to determine the condition of the roof membrane and details.
- This property is in acceptable condition and meets most of the recommendations of the urban analysis from Section 1 of this report.

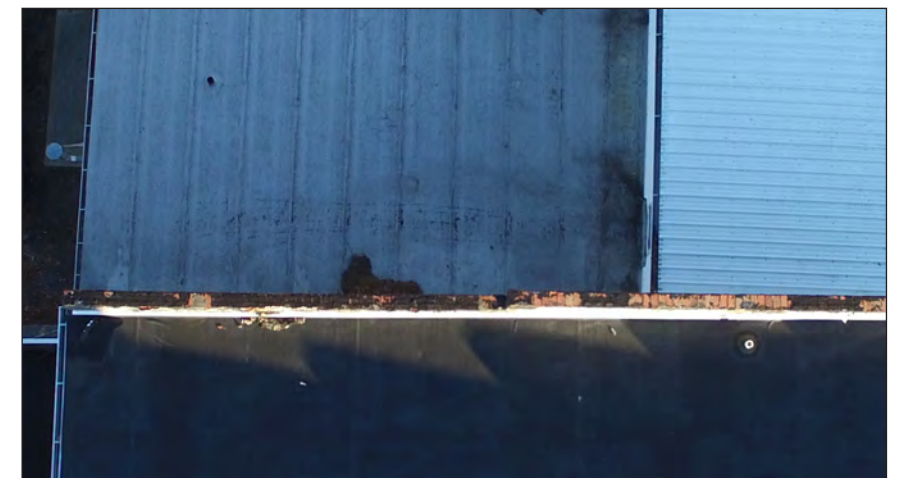
LOOSE MASONRY

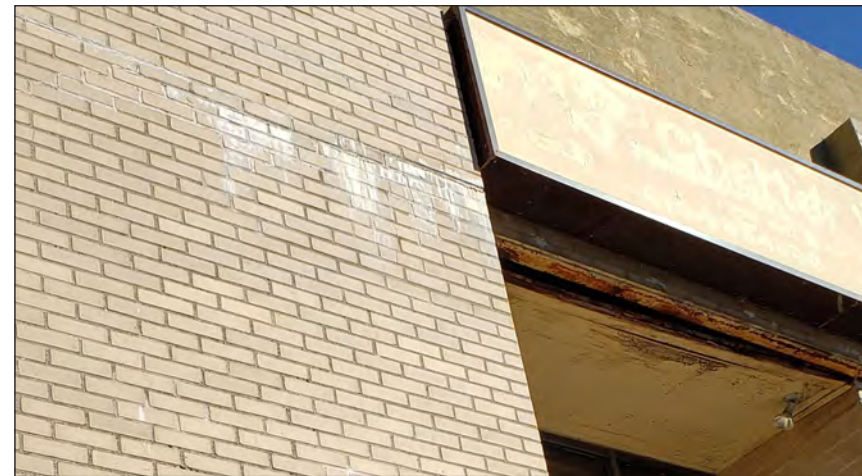
- Cracks / spalling parging
- Efflorescence
- Rusting shelf and damaged ceiling due to water infiltration at the top of the wall
- Lintel Corrosion

EFFLORESCENCE AND SHELF DAMAGE

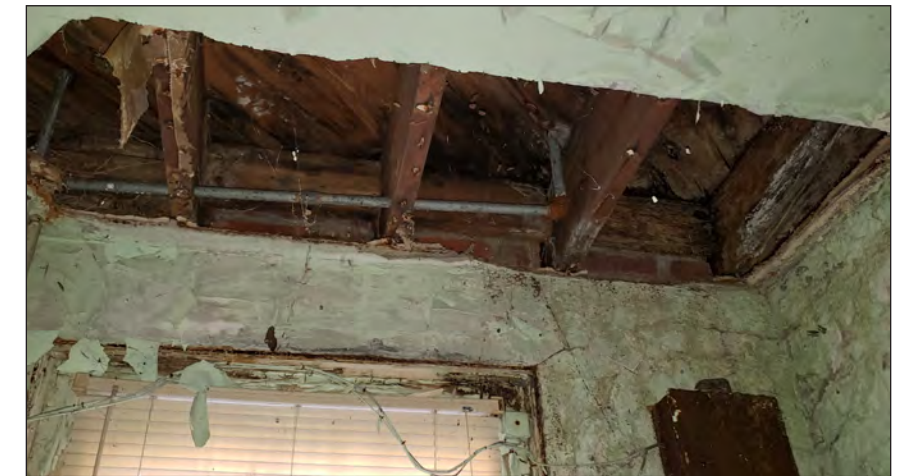
- 2nd floor joists damaged in the southwest front corner.
- Extensive water damage of an area approximately 10' x 20' in size, located in the front southeast corner was observed. In this area, 1st floor, 2nd floor joists, ceiling joists and rafters are damaged
- Access to the 2nd floor in the front of the building was limited due to extensive water damage to the stairs, rendering them unsafe.
- Evidence of water infiltration to the east and west façade was observed
- Stairs located in the rear interior of the building have extensive damage
- Roof rafters, 2nd floor framing, and all lintel damage was observed at the rear of the building due to a roof leak.
- Lintel jacking cracked masonry and window lintel damage was observed at the rear wall of the building

2ND FLOOR FRAMING LINTEL DAMAGE

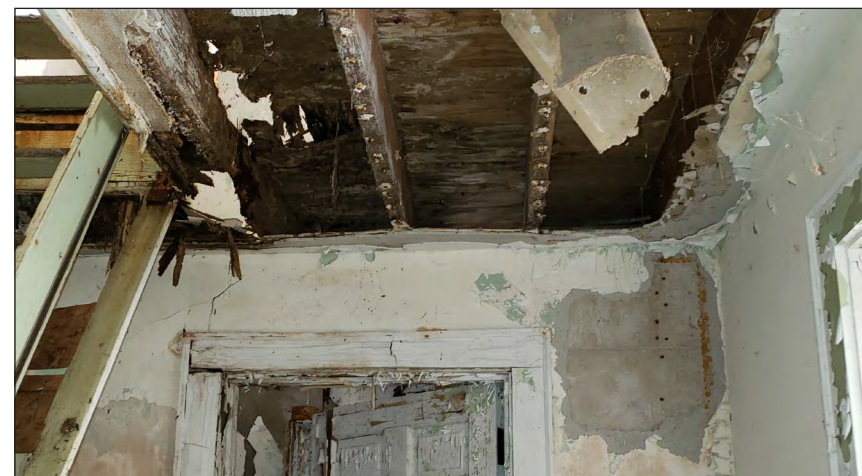
2ND FLOOR & STAIR DAMAGE

- The roof framing and roof membrane should be replaced.
- Water damaged interior floors, walls, and stairs should be replaced.
- The façade should be pressure washed.
- The ceiling above the entry should be replaced and new recessed light fixtures should be installed.
- The window frames and sills should be scraped and painted and any rotting wood should be repaired.
- The bulletin mounting board to the east of the front door should be removed.
- The planters adjacent to the entry should be cleared of weeds and new plantings should be installed.

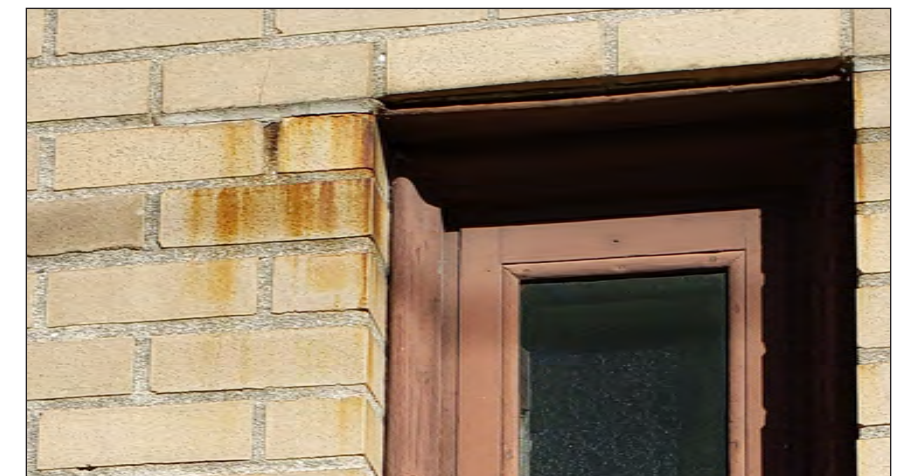
FRONT FAÇADE LINTEL CORROSION

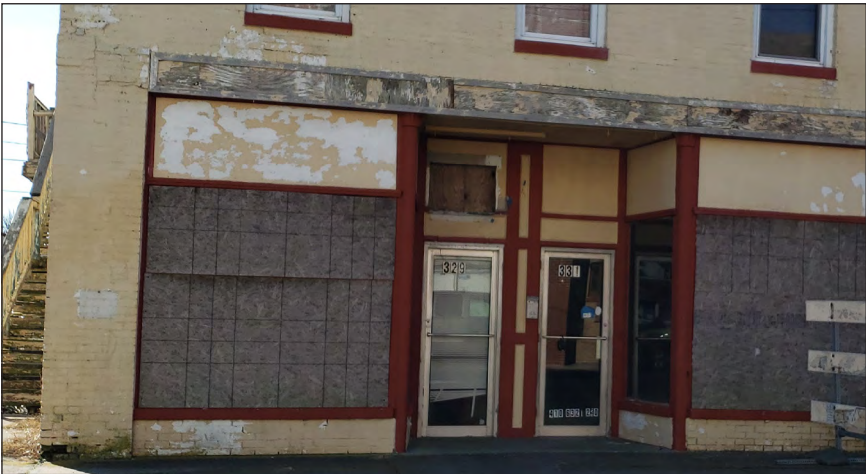
- Racking/cracked masonry at lintel locations and missing masonry units at lower northeast corner of the building.

SOUTH FAÇADE

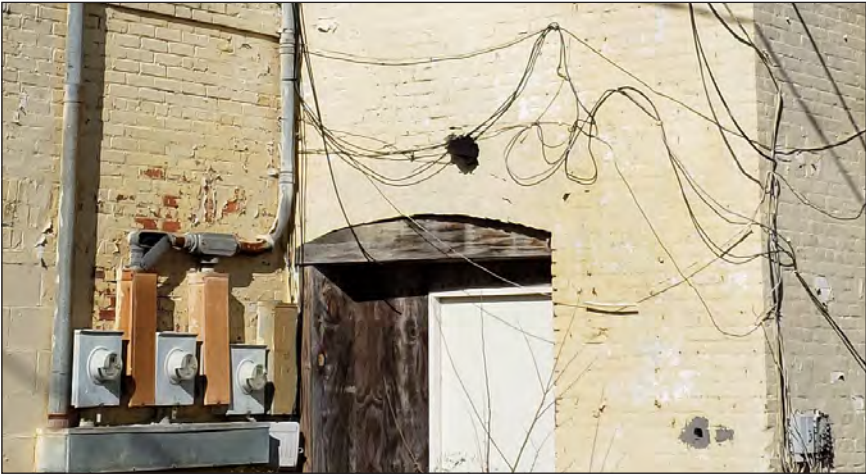
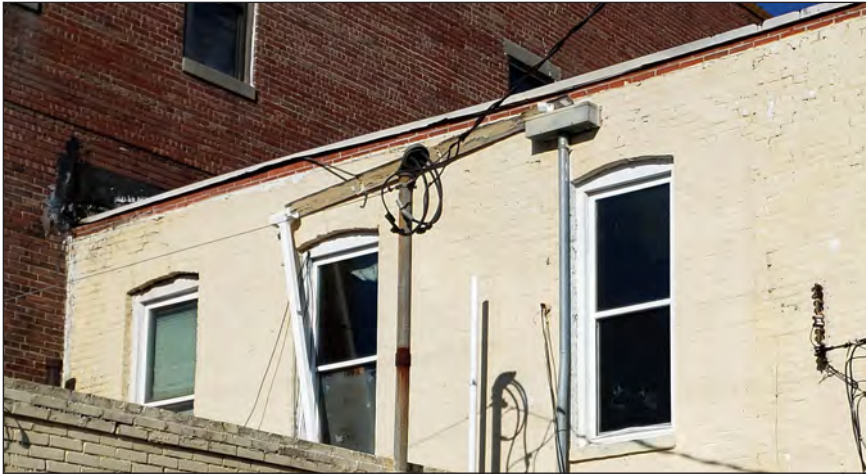
- Racking masonry at lintel locations on the rear façade.
- A hole in the masonry was observed.

REAR FAÇADE CONDITION

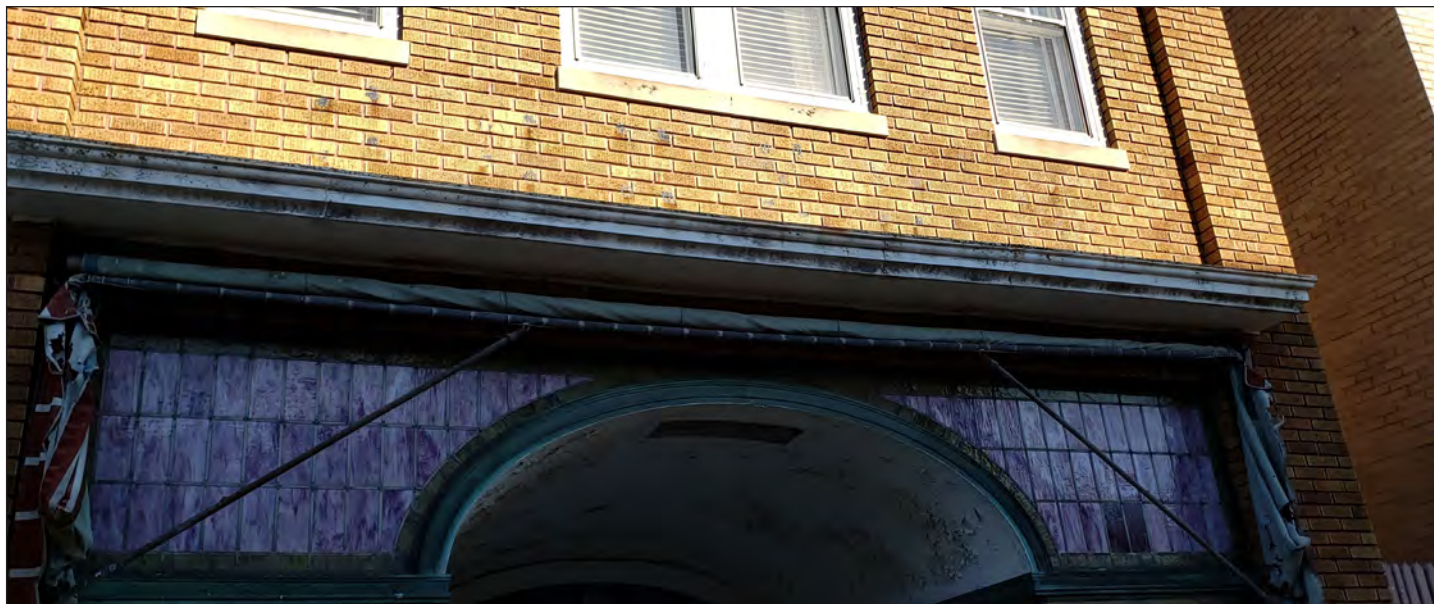
- Moderate lintel corrosion was observed at the storefront window

LINTEL CONDITION

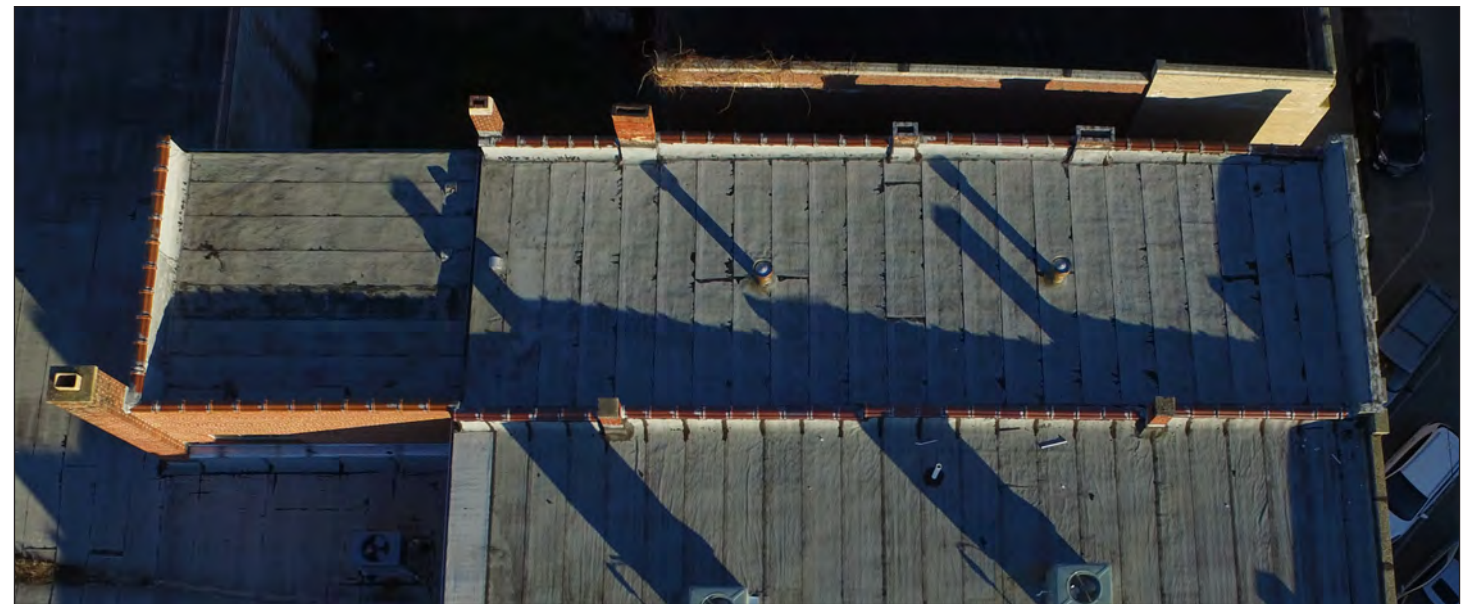
- Condition of the roof is observed to be in adequate condition based on imagery

ROOF CONDITION

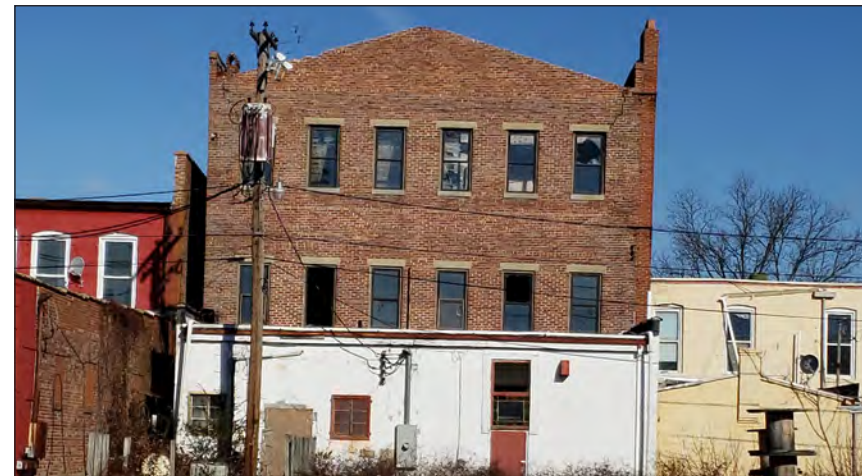
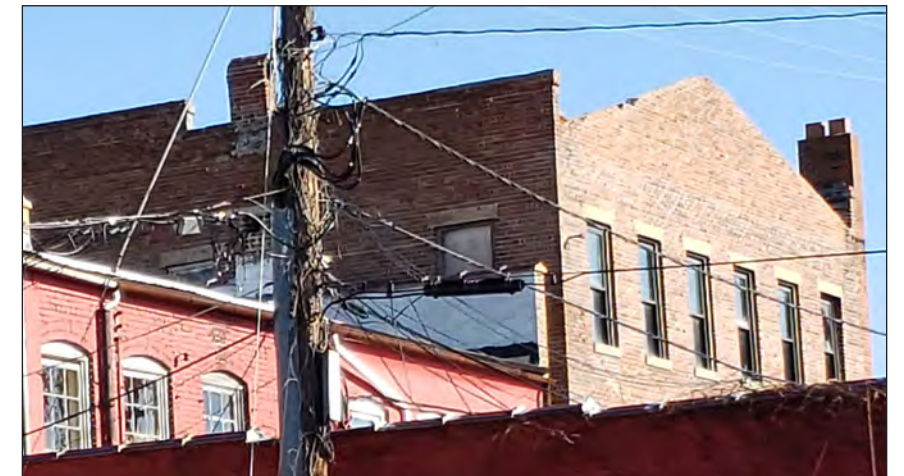
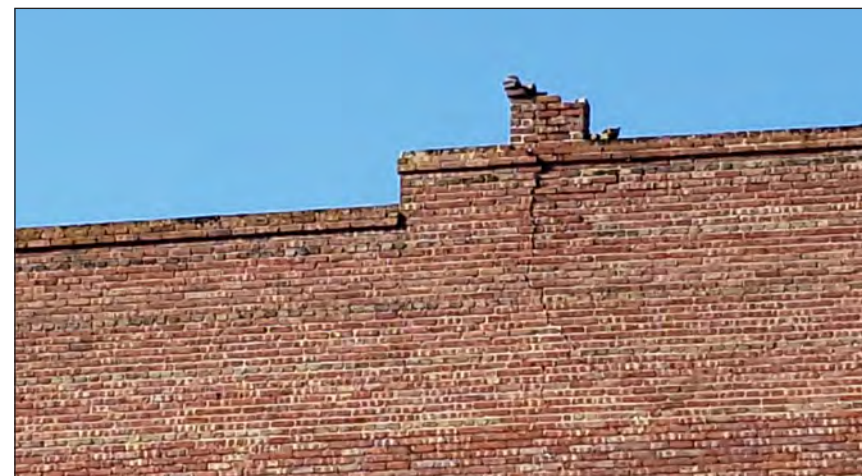
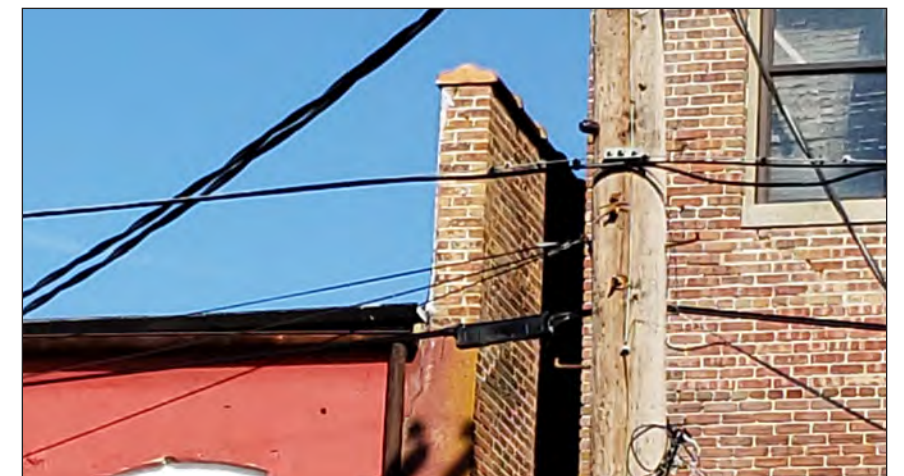
Becker Morgan Group, Inc. observed that the structural integrity has been compromised due to the collapsed roof. BMG recommends immediate attention to this building to prevent damage to the buildings to the East and West. Further investigations are recommended to determine the condition of the 1st and 2nd floors.

- Caution tape was placed at the front of the building due to the unsafe nature of the building. The roof has completely collapsed at the south and is collapsing at the north, making the structure unsafe.
- Masonry cracks were observed in the façade of the building.

- The existing structure is in severe disrepair and the costs to restore it will likely be too great based on the significance of the building.
- This report recommends demolishing the structure and preparing the site for new construction. The adjacent party walls should be reviewed by a structural engineer and repaired, as required.

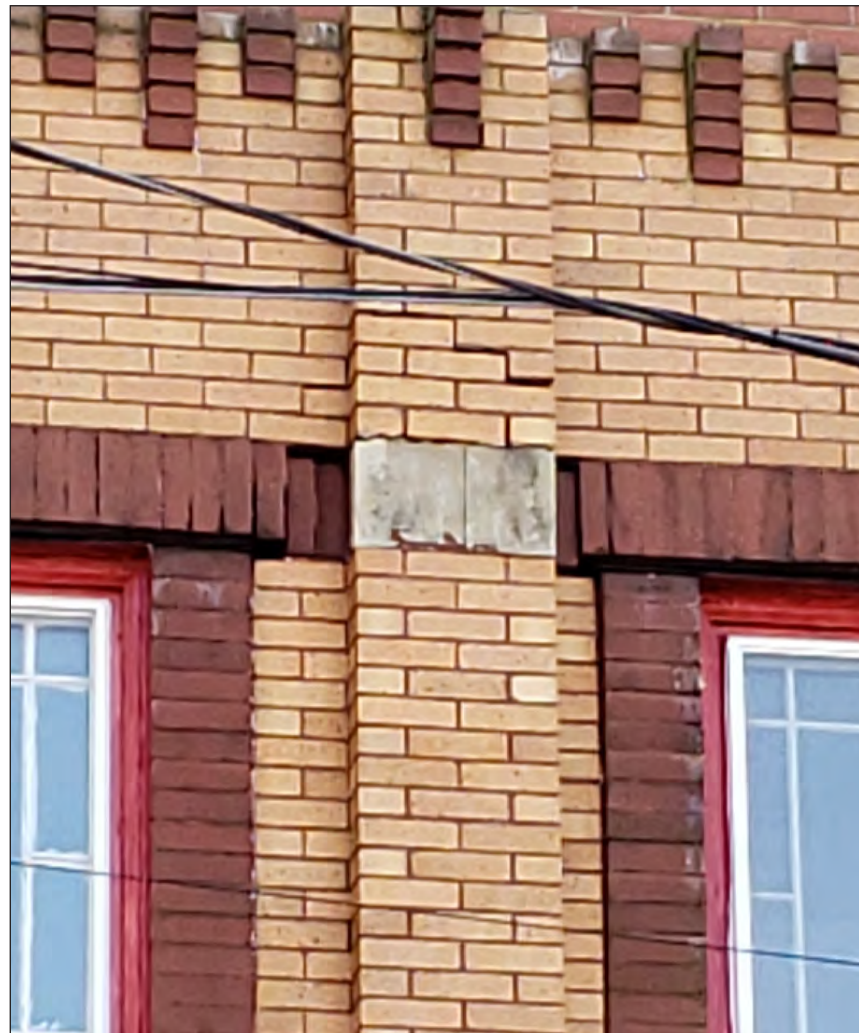
- Displacement/racking of masonry above windows.
- Cracking of masonry between windows at lintels.

FRONT FAÇADE CONDITION

- The roof should be inspected by a roofing manufacturer or installer to determine the condition of the roof membrane and details.
- Open masonry joints should be inspected and repointed.
- The existing metal awnings should be pressure washed and repainted. Existing signage should be removed before painting.
- The existing illuminated sign should be removed.
- In tenant space 335, the existing windows are likely not thermally insulated. Energy efficiency, utility costs, and general comfort in the building will be improved by replacing these windows with a new thermally insulated storefront system. While, this is likely an issue on tenant spaces 337 and 339, the areas behind these windows are still utilized as shop displays and separated from the interior by an additional wall.

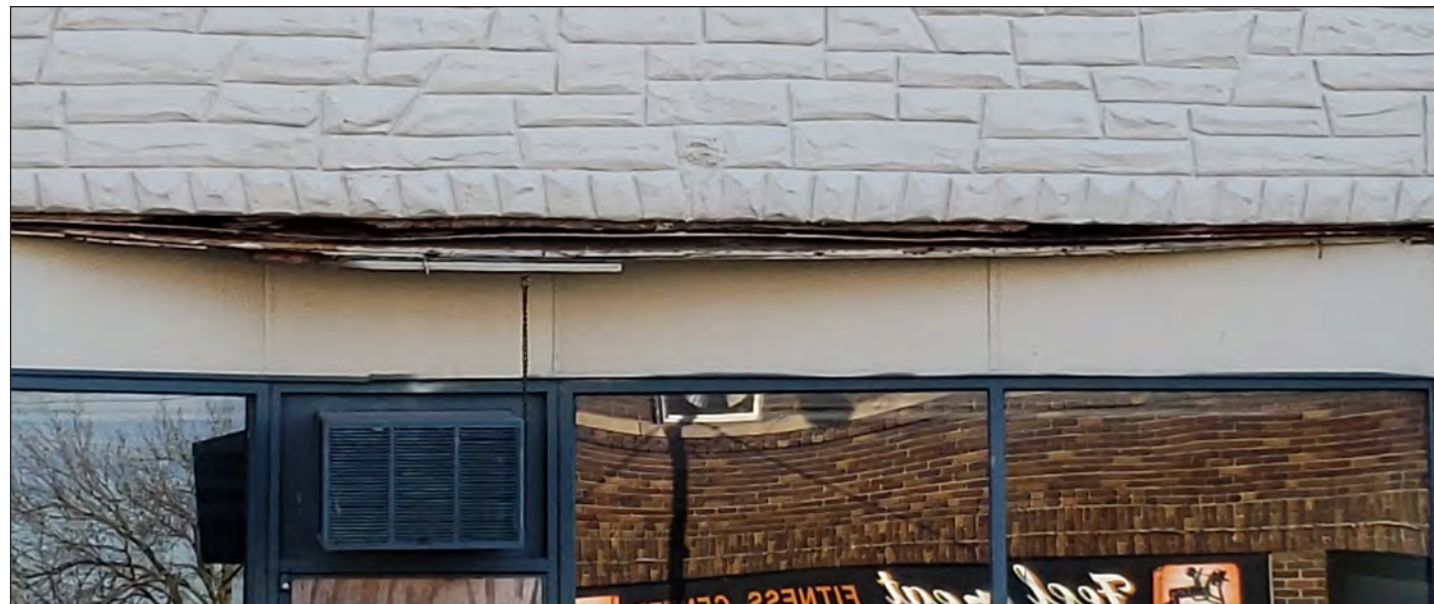
- Lintel corrosion at the storefront of 341.
- Cracked masonry on the west façade.
- The building's floor framing and roof framing are left exposed to the exterior environment as a result of the demolition of the building to the west.

FRONT FAÇADE LINTEL CONDITION

- The missing shutter on tenant space 341 should be replaced.
- The exposed lintel on tenant space 341 should receive a protective covering to match the condition on the other tenant spaces.
- The exposed roof and floor framing adjacent to lot 351 should be protected from the elements with metal capping and painted to match brick.
- The remaining plaster and roof sealant from the demolished structure on lot 351 should be removed.
- The brick adjacent to lot 351 should be pressure washed and repointed.

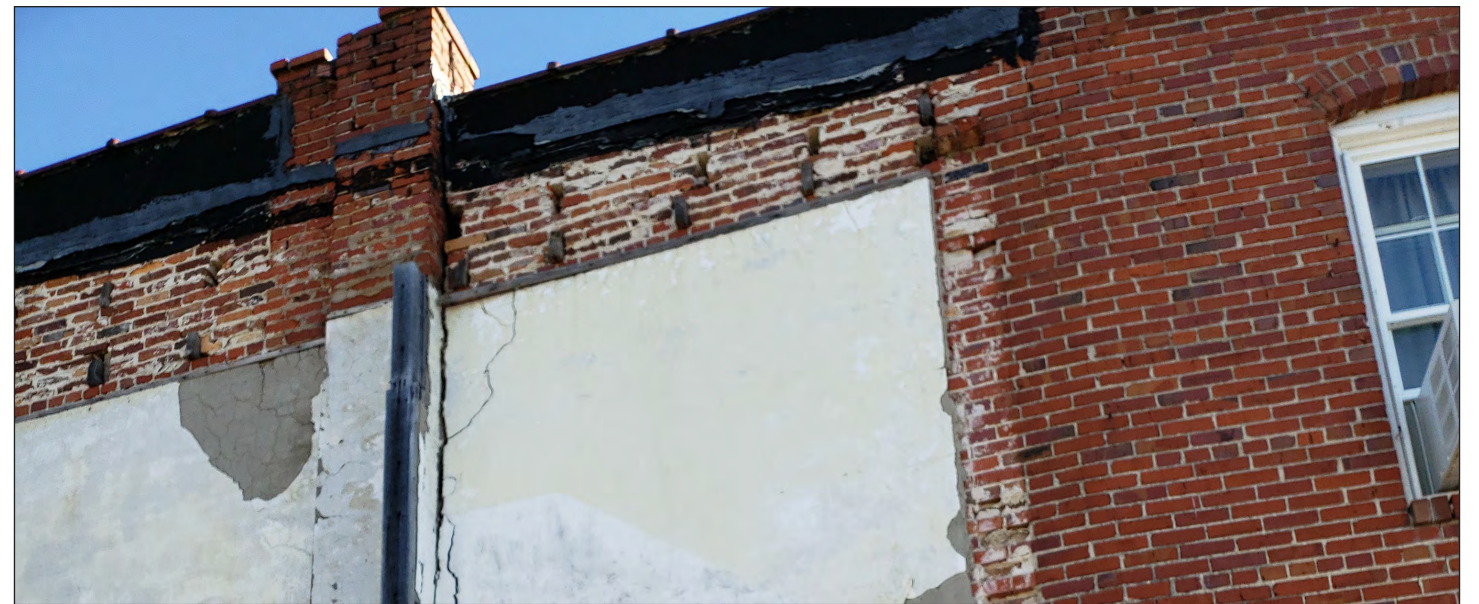
WEST FAÇADE CONDITION

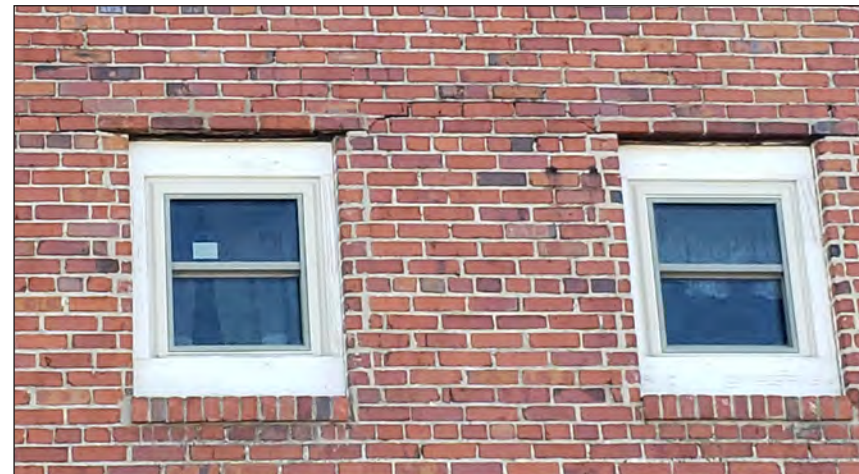
- Lintel corrosion and masonry racking at windows.

TYPICAL LINTEL CONDITION ON WEST FAÇADE

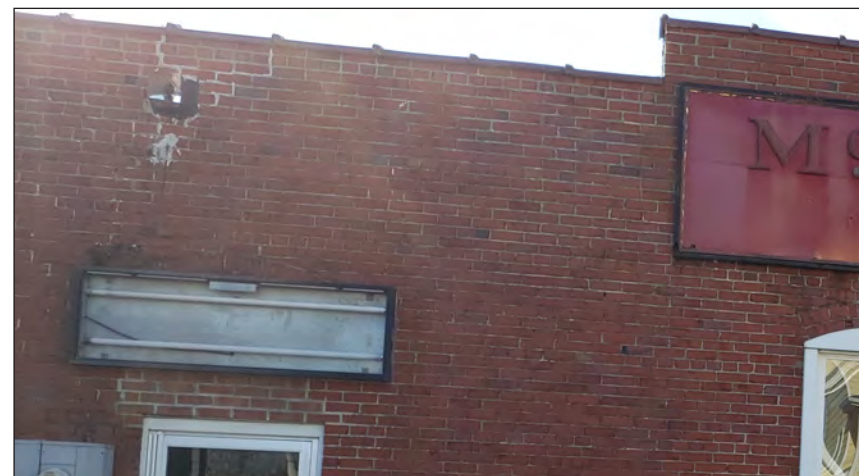
- Efflorescence and evidence of repairs indicate water infiltration

REAR OF BUILDING CONDITION

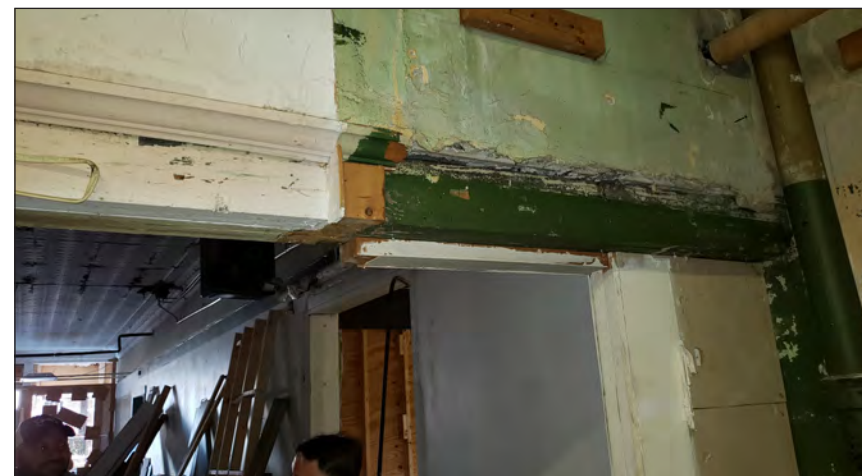
LINTEL CORROSION

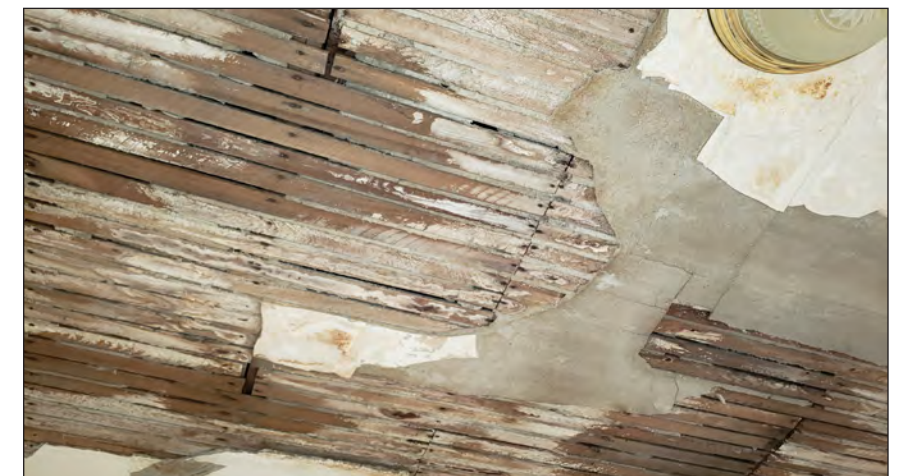
- Water damage to interior walls and ceiling framing at the upper levels due to water infiltration
- Uneven floors were observed, indicating there is an issue with the framing
- Gap / hole between wall and roof framing was observed at the interior southeast corner
- Evidence of water infiltration was observed at the interior walls 1st floor level
- Deflection of trusses were observed at the east side of the structure
- Interior 2nd floor framing damage was observed. Corrosion to lintels, cracks and deflection was observed in supporting beams / walls
- Water damage to upper level floor framing was observed

TYPICAL CEILING WATER DAMAGE

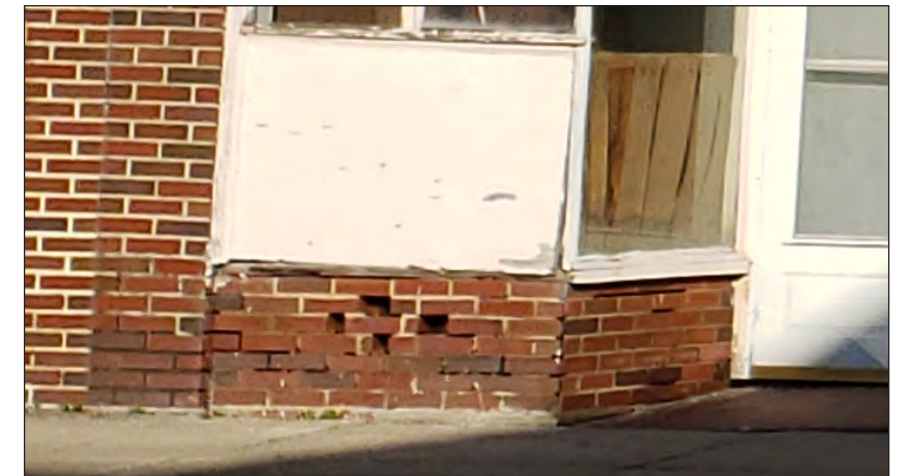
DISPLACED/MISSING MASONRY UNITS

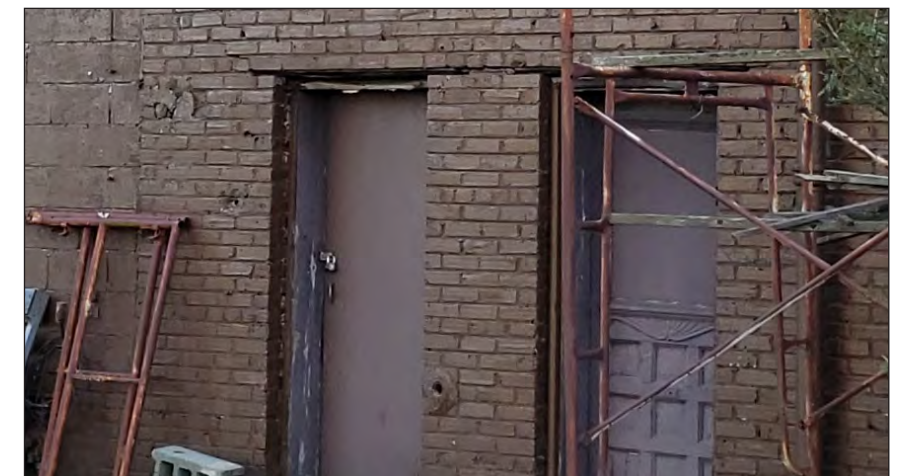
TYPICAL LINTEL/MASONRY CONDITION

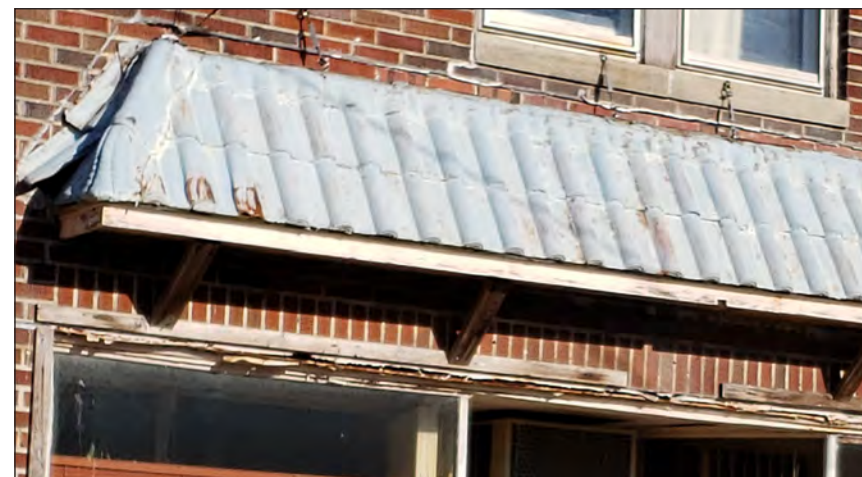
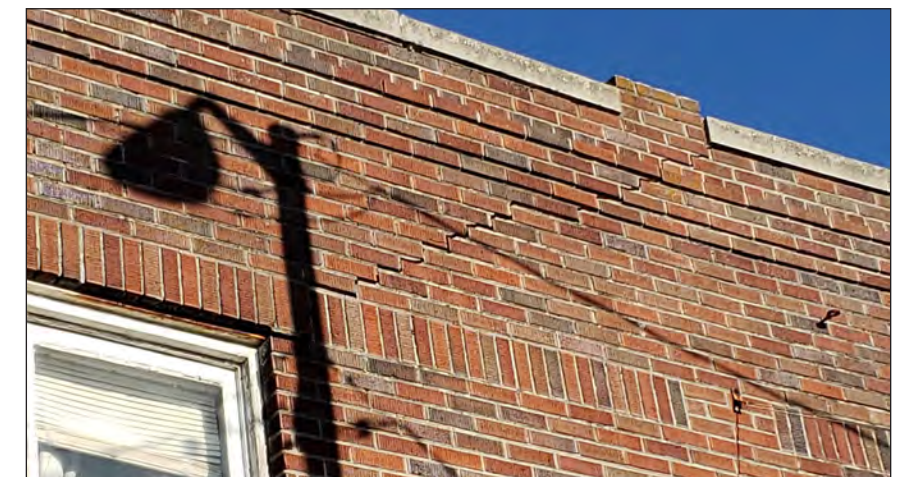
- Lintel corrosion, racking masonry and cracked masonry.

TYPICAL LINTEL CONDITION

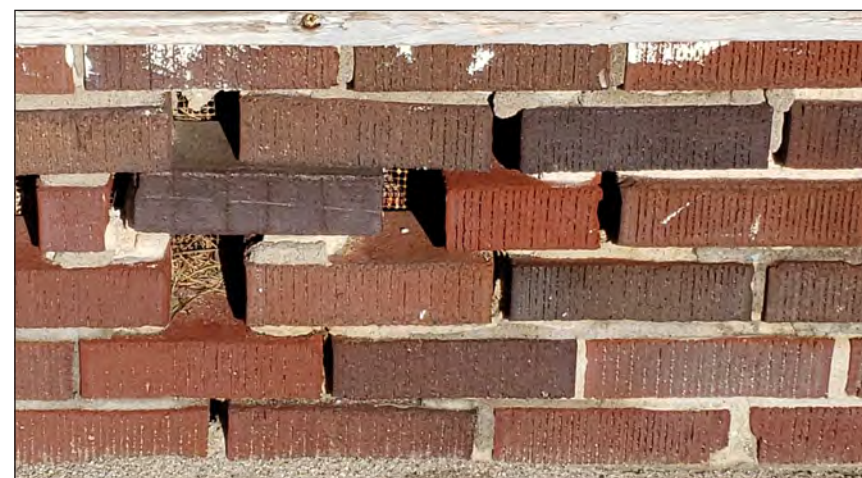
DISPLACED MASONRY UNITS

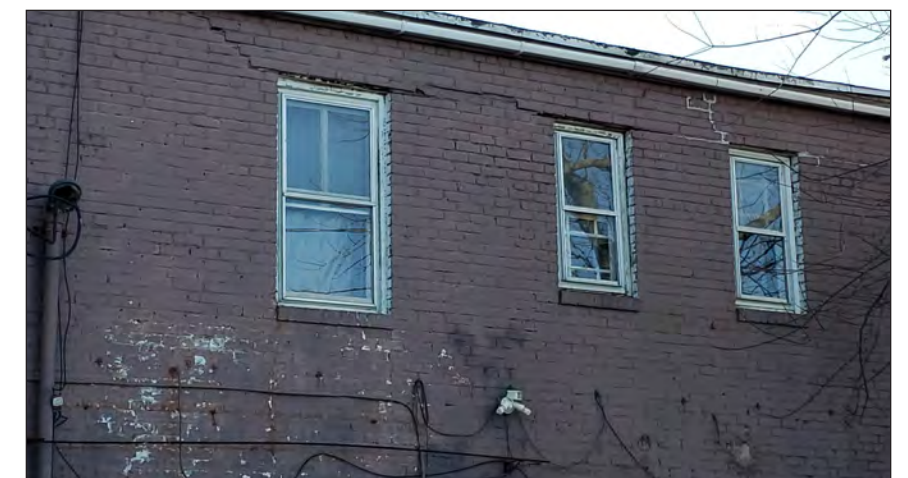
REAR FAÇADE CONDITION

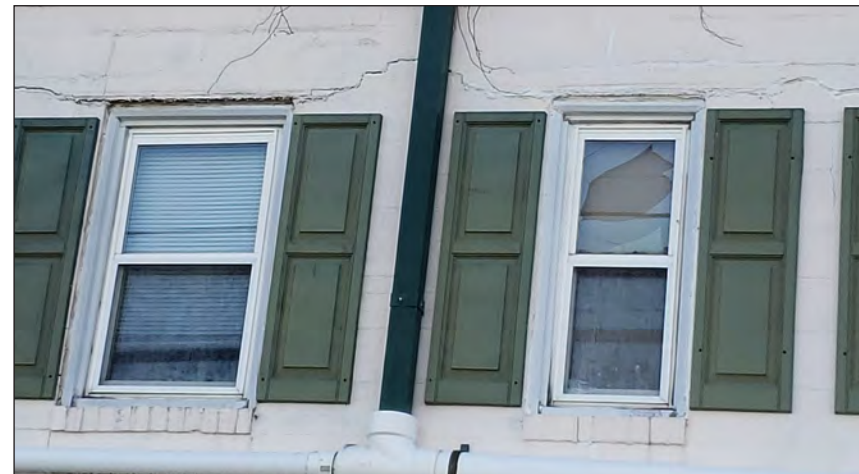
LINTEL CONDITION

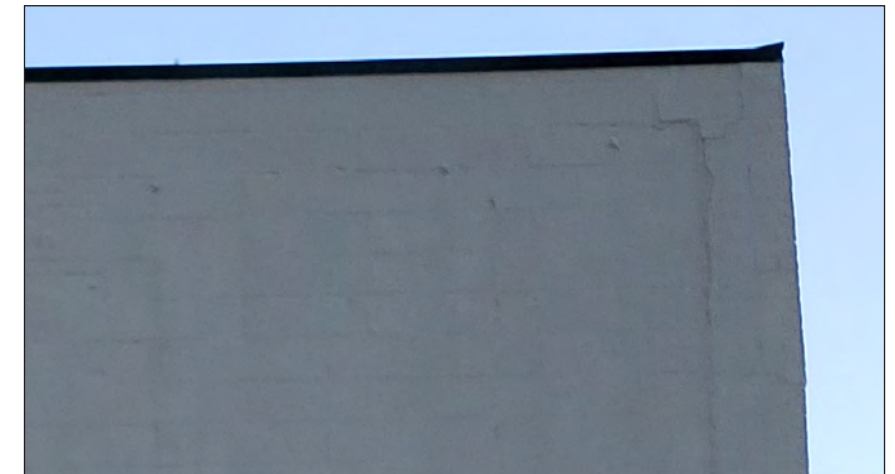
CRACKED/RACKING MASONRY

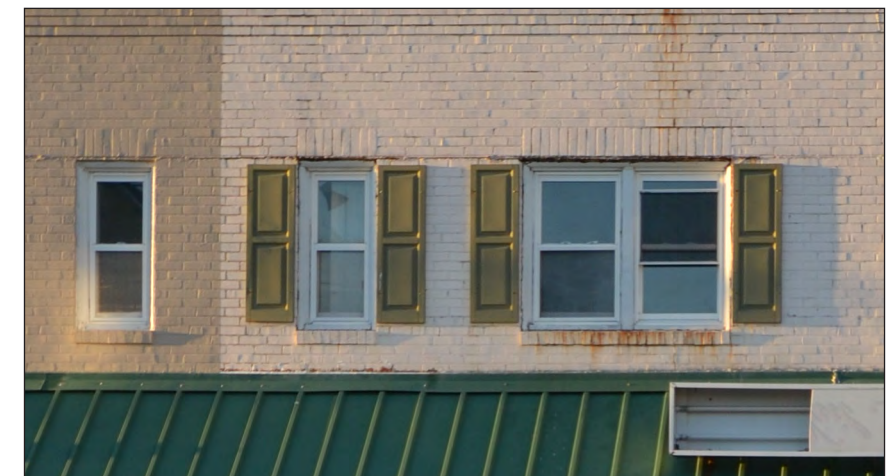
TYPICAL LINTEL CONDITION AT 2ND FLOOR FRONT WINDOWS

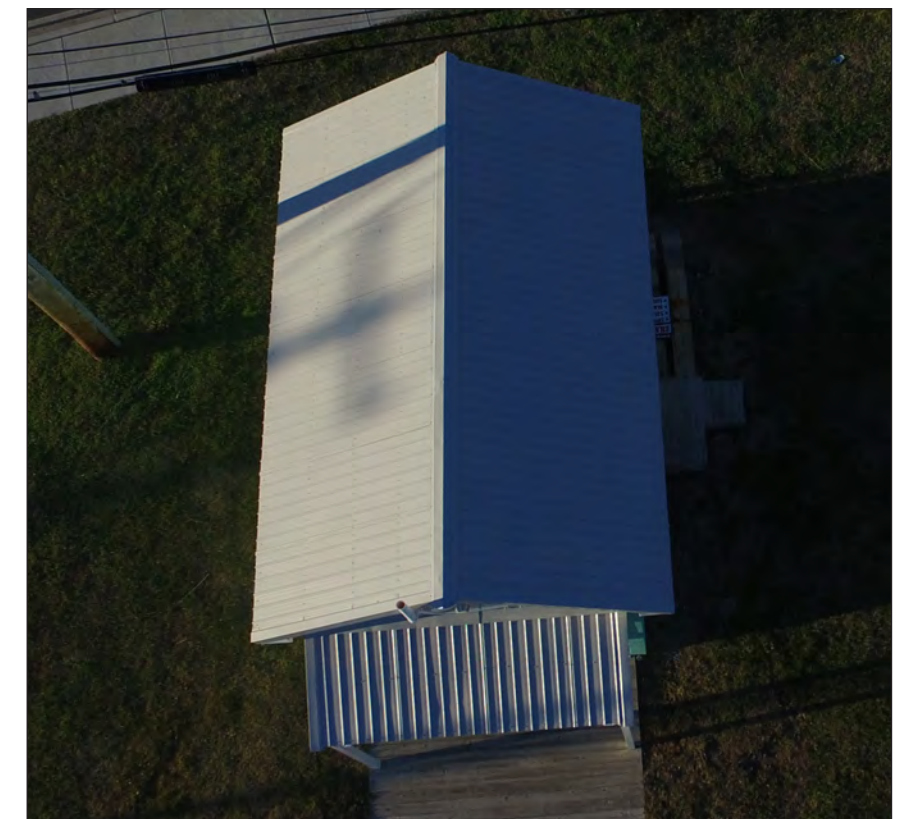
ROOF CONDITION

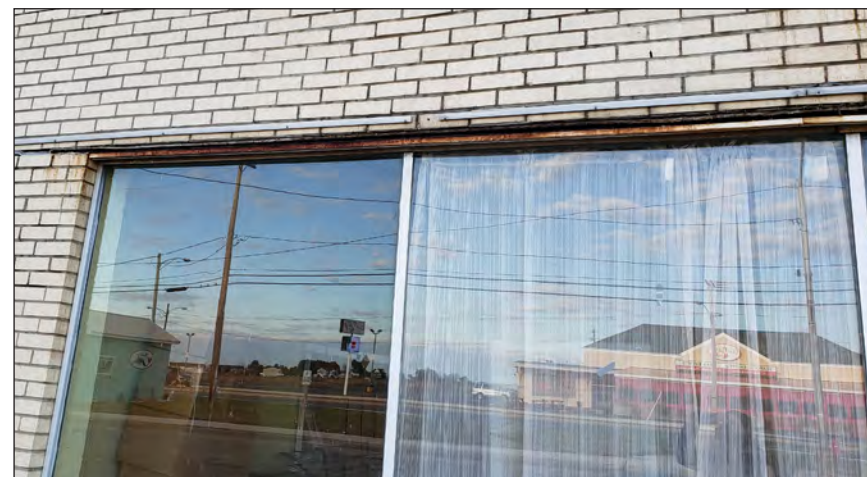
STORE FRONT LINTEL CONDITION

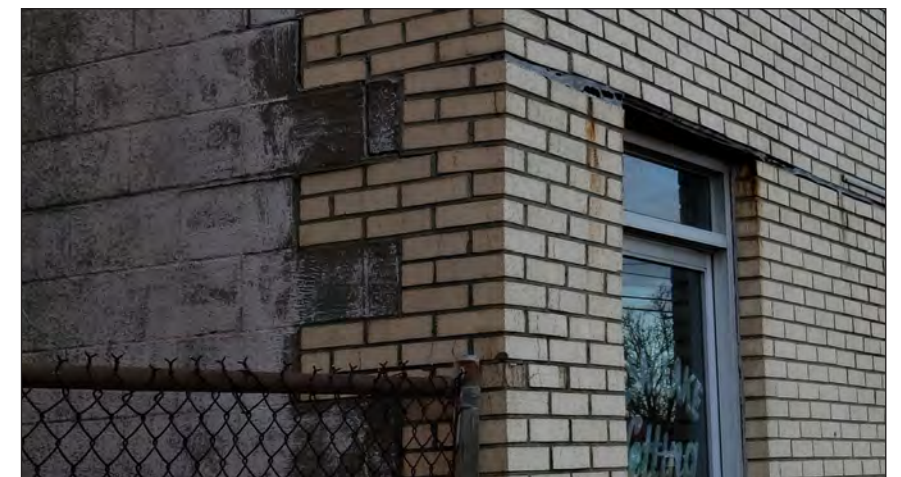
NORTHEAST CORNER MASONRY CONDITION

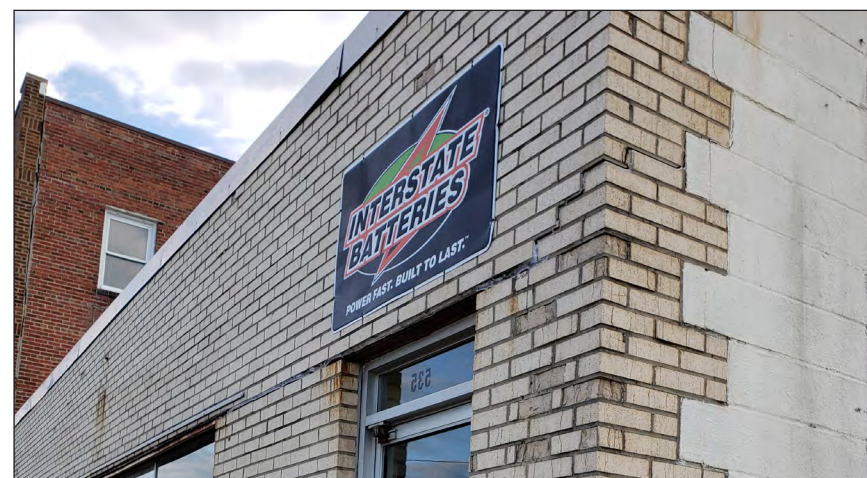
NORTHWEST CORNER MASONRY CONDITION
