FEASIBILITY STUDY

# CRISFIELD DOWNTOWN

SAGE POLICY GROUP

JANUARY 2020

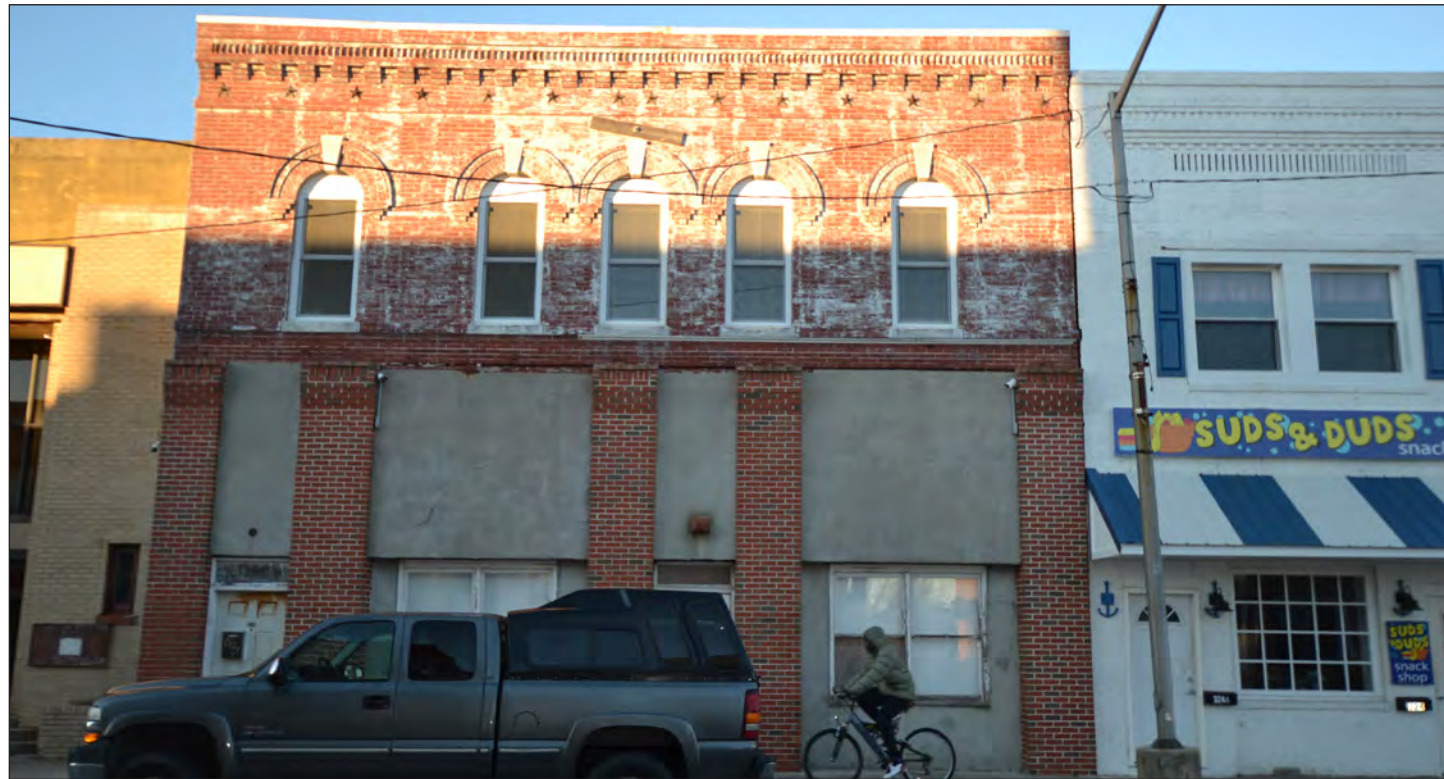
Observations:  
This structure has been and is in the process of renovation. There are no structural concerns to note based on the condition of the structure at the time of the site visit.

TYPICAL EXTERIOR CONDITION

- The ground floor windows and front entry doors should be replaced.
- The second-floor brick façade should be pressure washed and painted.
- The brick support located just above the second-floor middle window should be straightened and painted to match brick.

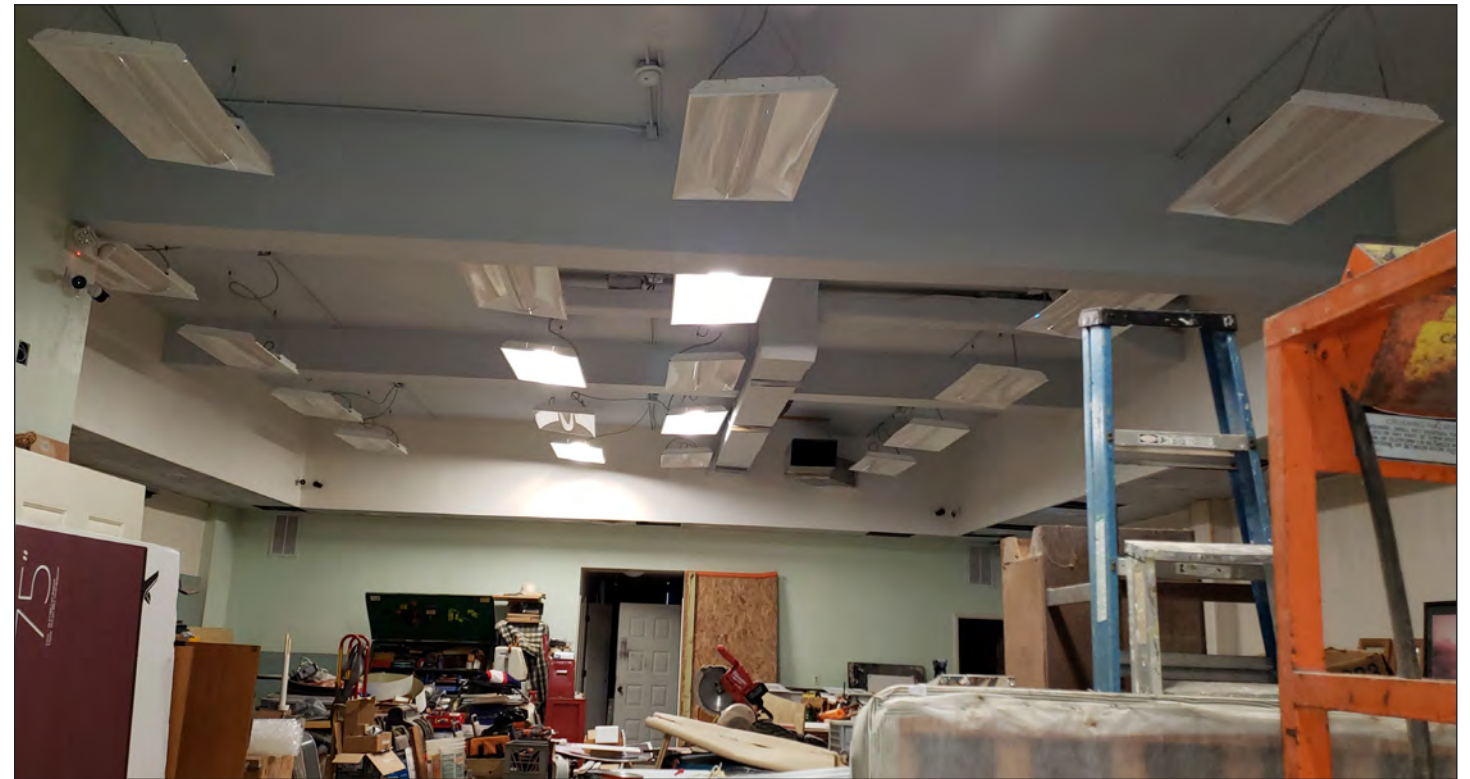
TYPICAL INTERIOR CONDITION

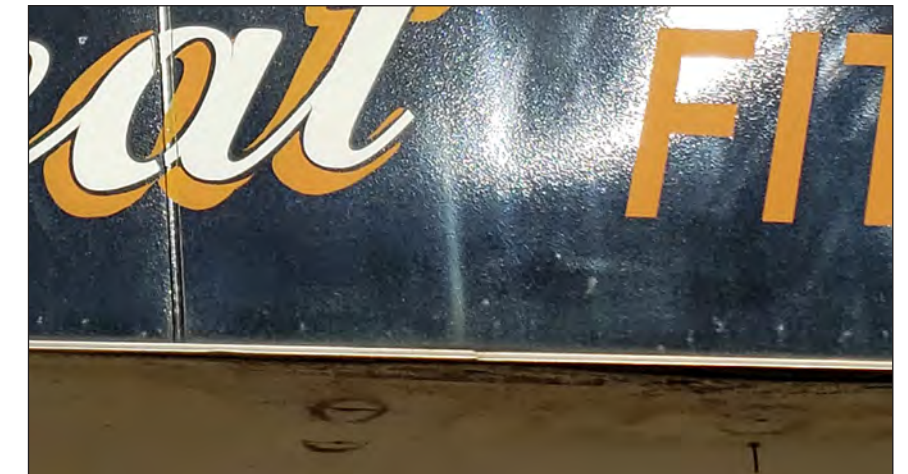
- Lintel corrosion at storefront for address 382 W. Main Street
- Lintel corrosion and masonry racking at windows.
- Lintel corrosion at storefront for address 386 W. Main Street
- Cracked masonry

386 W. MAIN STREET STORE FRONT CONDITION

- The roof should be inspected by a roofing manufacturer or installer to determine the condition of the roof membrane and details.
- Corroded lintels should be sandblasted and coated with an industrial epoxy paint.
- Brick façade should be pressure washed and repointed.
- Unused signage frame at rear of building should be removed.
- Diagonal wood siding on exterior of tenant spaces 382 and 384 should be sanded and refinished.
- The water damaged wood behind the storefront in tenant space 390 should be removed or replaced.

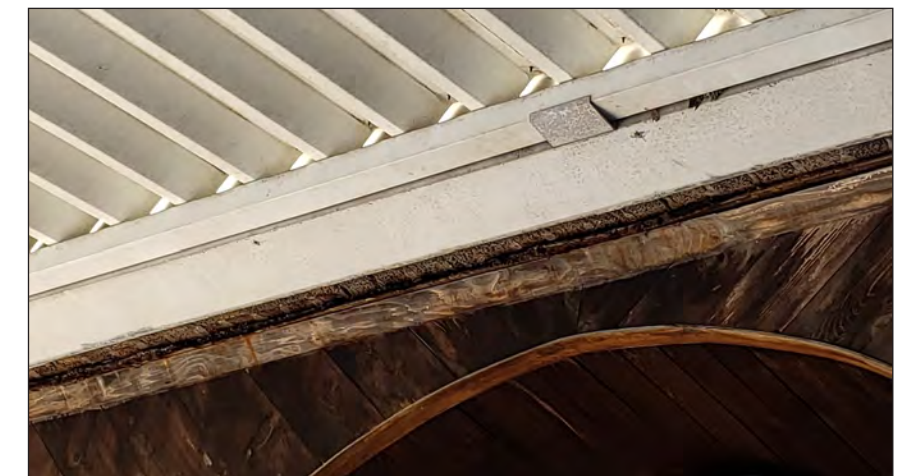
382 W. MAIN STREET STORE FRONT CONDITION

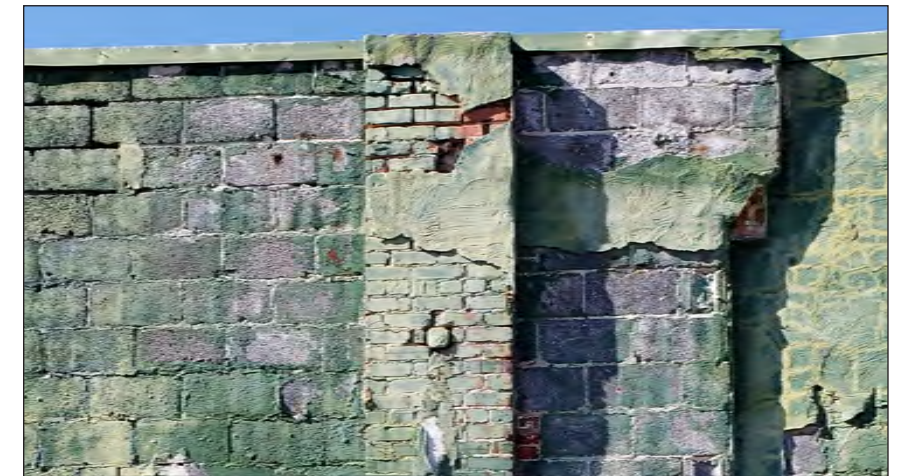
- East exterior wall consist of a combination of metal siding and CMU. The CMU wall is very porous, has developed blisters, parge coat has failed and column caps damaged
- Cracked masonry, lintel corrosion and efflorescence were observed at the west and rear walls
- Chimney detachment
- Water damage to framing under roof overhang
- Fire Escape platform is corroded
- Signs of water infiltration at the roof level was observed

TYPICAL CMU WALL CONDITION

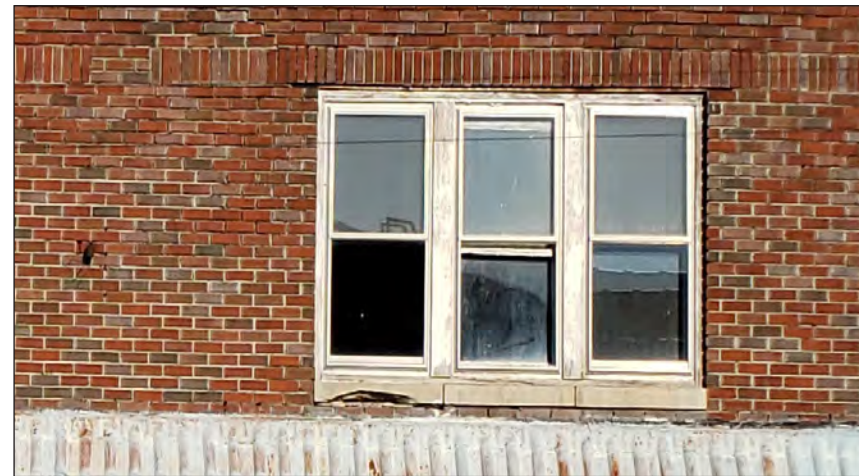
TYPICAL WINDOW CONDITION

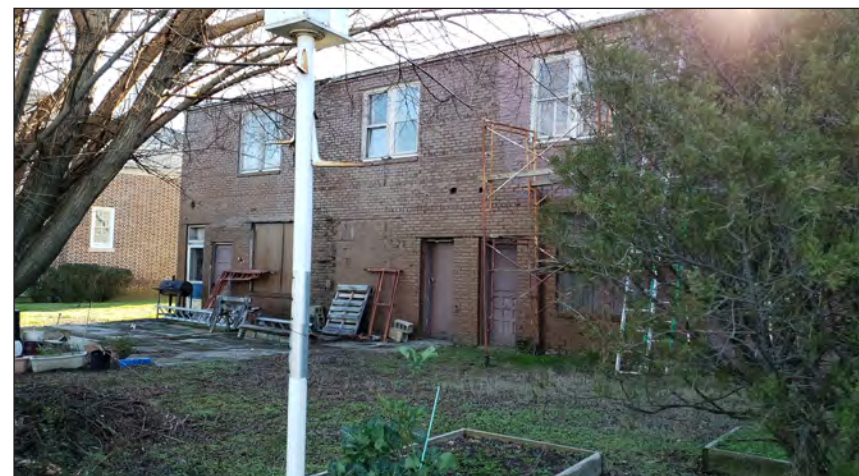
REAR FAÇADE CONDITION

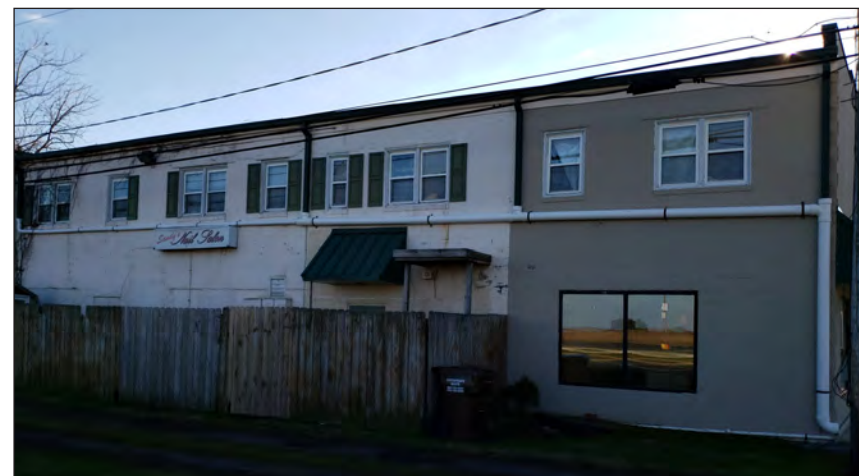
REAR FAÇADE CONDITIONS

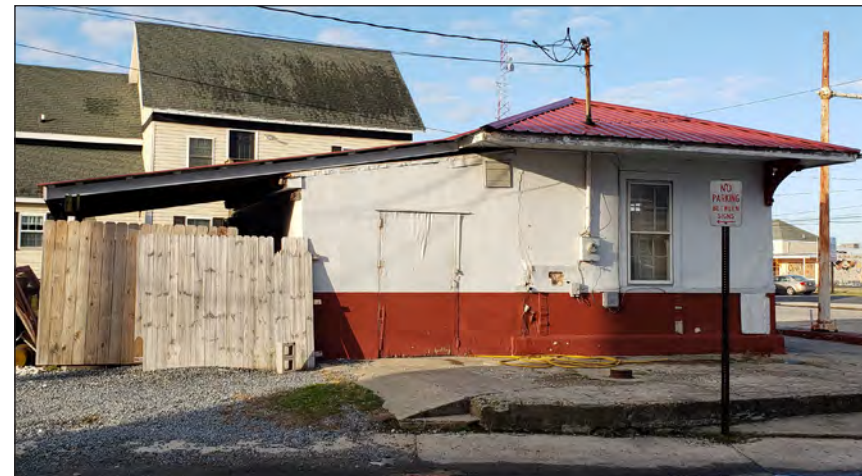
WEST FAÇADE CONDITION

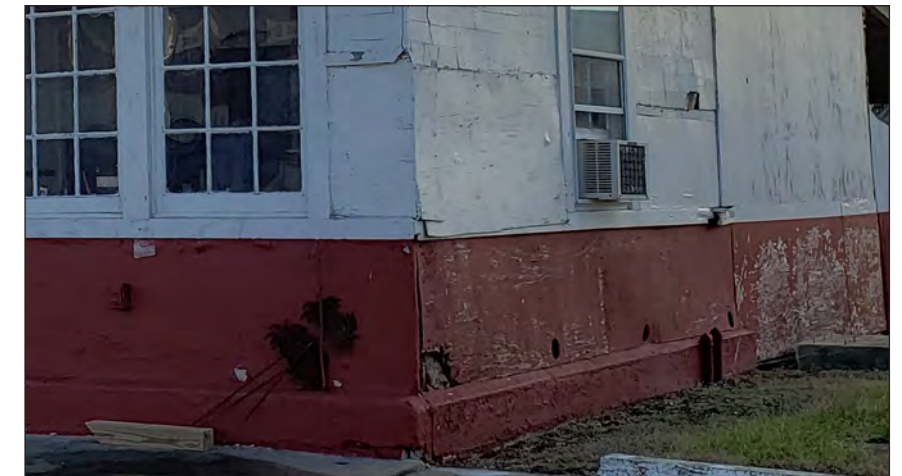
EAST FAÇADE CONDITION

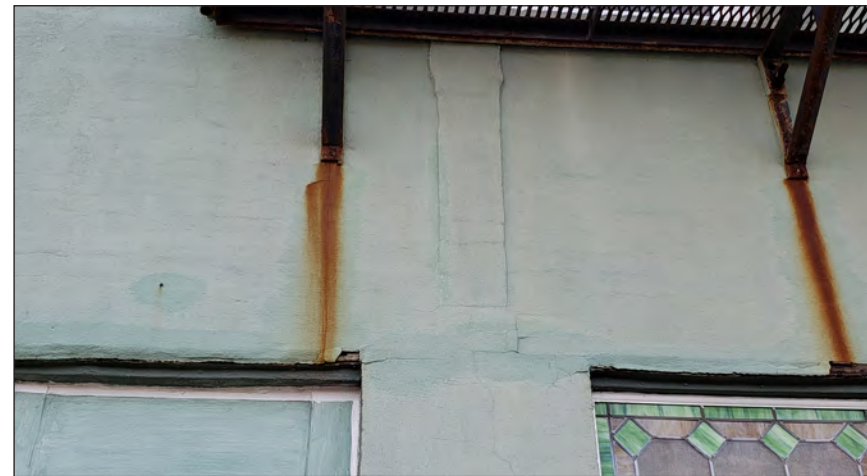
- Lintel corrosion at windows and fire escape framing and cracked masonry on the front façade.

FRONT FAÇADE CONDITION

- The exterior fire escape is rusting and staining the façade. It should be sandblasted and coated with an industrial epoxy paint.
- Corroded lintels should be sandblasted and coated with an industrial epoxy paint.
- The brick façade should be pressure washed and mortar joints should be repointed.
- The façade requires repainting.

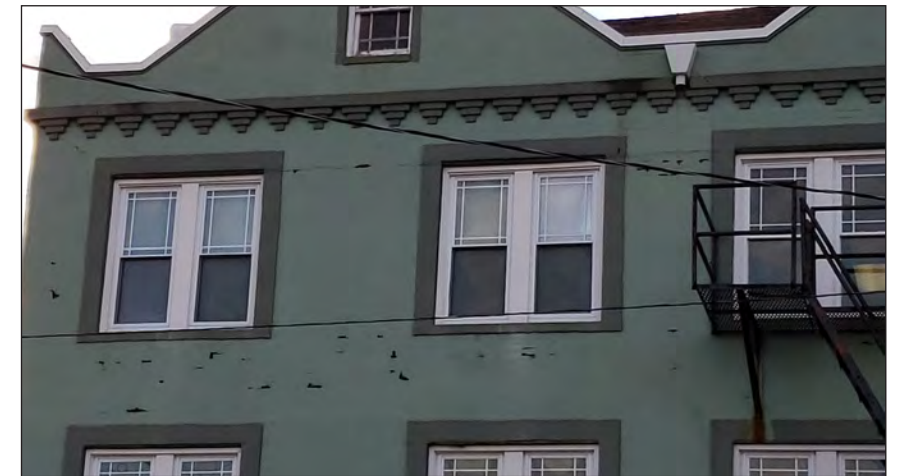
- Cracked masonry and masonry racking observed at lintel locations on the east façade.
- Peeling of paint was observed and could be an indication of water infiltration.

EAST FAÇADE CONDITION

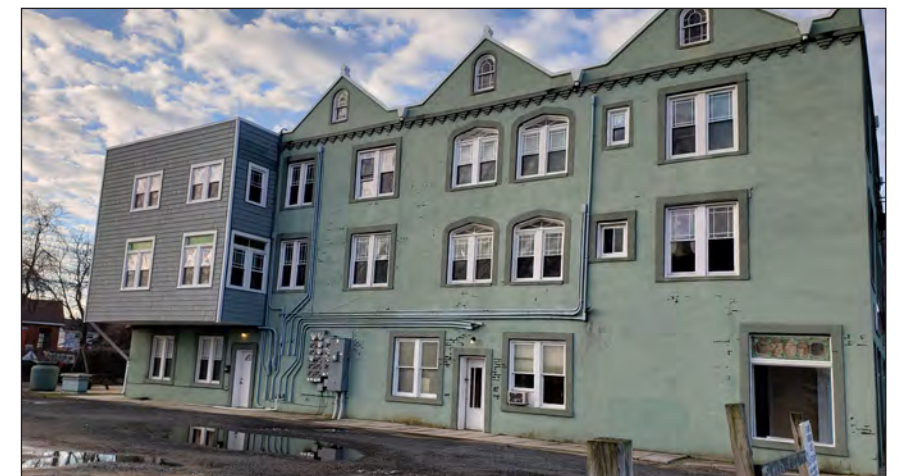
EAST FAÇADE CONDITION

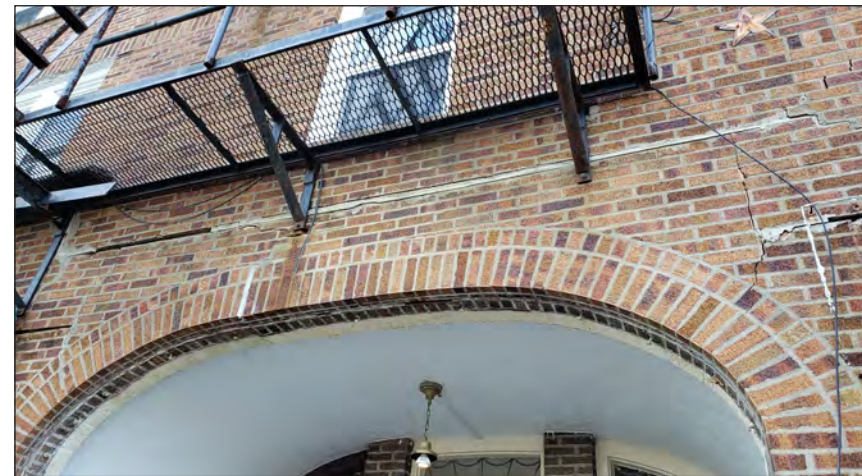
- Efflorescence and cracking of masonry on the front façade.

FRONT FAÇADE CONDITION

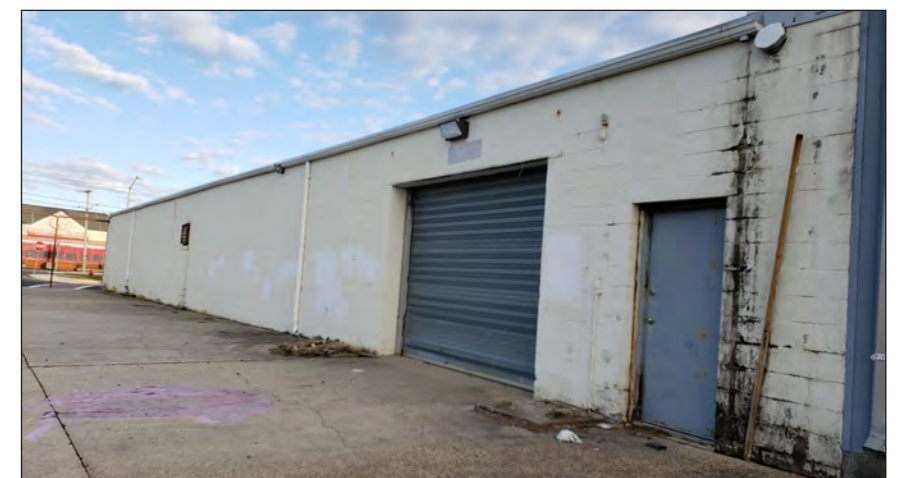
WEST FAÇADE CONDITION
