FEASIBILITY STUDY

# CRISFIELD DOWNTOWN

SAGE POLICY GROUP

JANUARY 2020

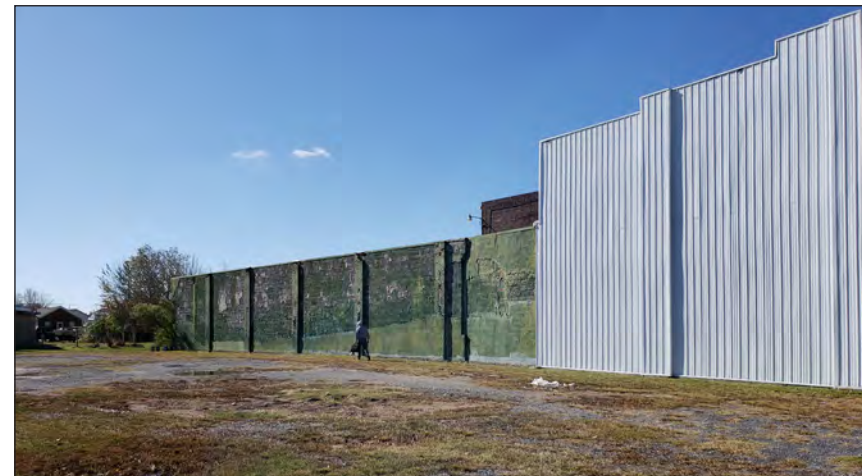
- East exterior wall consist of a combination of metal siding and CMU. The CMU wall is very porous, has developed blisters, parge coat has failed and column caps damaged
- Cracked masonry, lintel corrosion and efflorescence were observed at the west and rear walls
- Chimney detachment
- Water damage to framing under roof overhang
- Fire Escape platform is corroded
- Signs of water infiltration at the roof level was observed

EAST EXTERIOR WALL

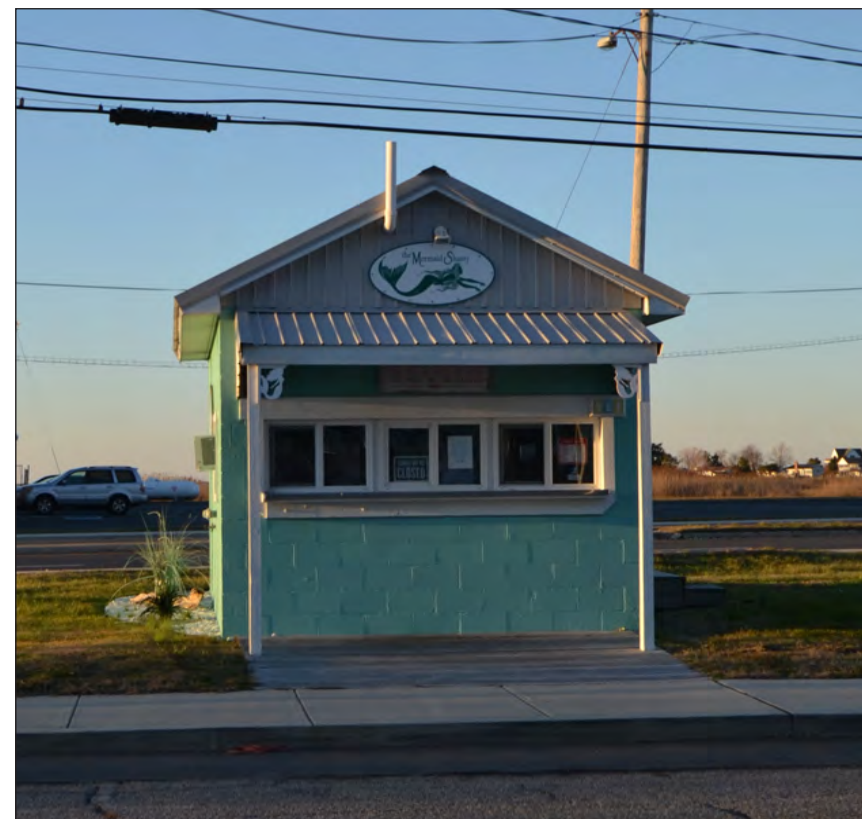
514 W. MAIN STREET

There are no structural concerns to note based on the condition of the structure at the time of the site visit.

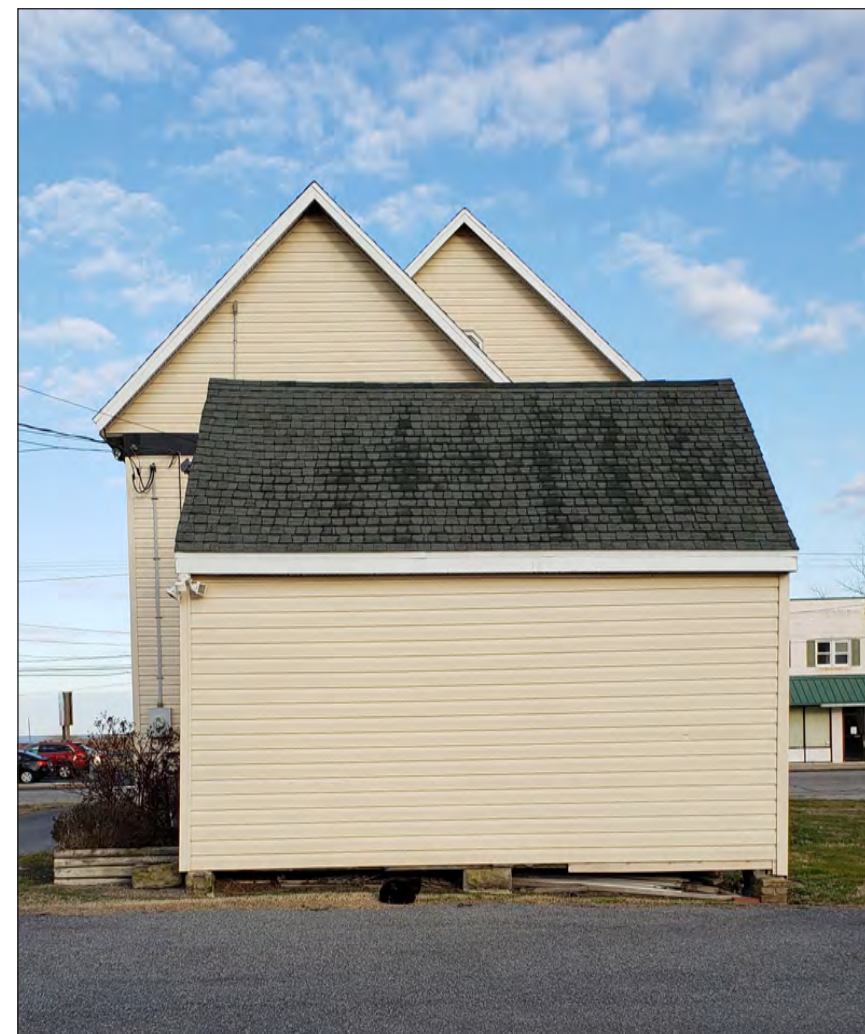
REAR FAÇADE

At the time of the site visit, the structure was observed to be in good structural condition.

- The building is in good condition
